Manhole Inspection Summary

Manhole # S09OO1005MH

Insp Date: **1/21/09 11:04 AM**

Location Address: **4930 PALMER AVE**

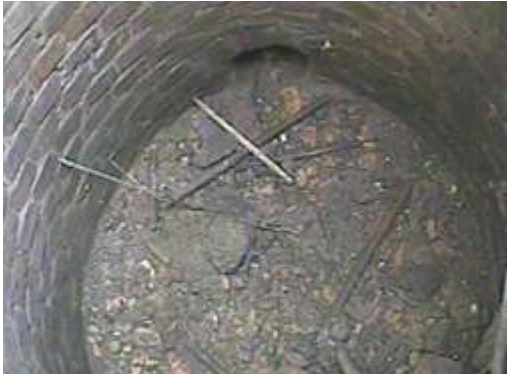
Defect 1

Condition: ☐ Sound ☐ Cracked ☐ Root Intrusion ☐ Deteriorated ☐ Leaks ☒ **Debris**

DEBRIS

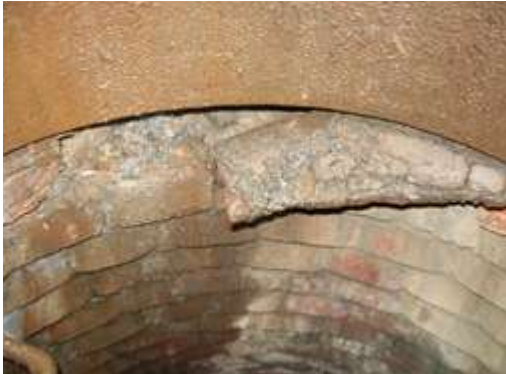
Defect 2

Condition: ☐ Sound ☐ Cracked ☐ Root Intrusion ☒ **Loose Brick** ☒ **Deteriorated**

DETERIORATED/LOOSE BRICK AT CHIMNEY

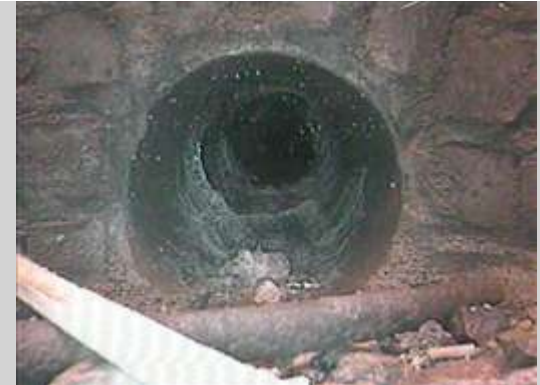
12 O'Clock Outflow

8 in. Circular Gravity Sewer
Pipe Out @ 12 O'Clock

Deposits: ☐ None ☐ Mud ☐ Sludge ☒ **Debris** ☐ Grease

Silt Depth: **2** (in.) Deposits Extent: **Medium**
